INVESTIGATION ON SERVICE YEARS OF LARGE RUBBER MARINE FENDERS

Key Words : rubber fender, durability, service years, failure modes, compression test, field survey

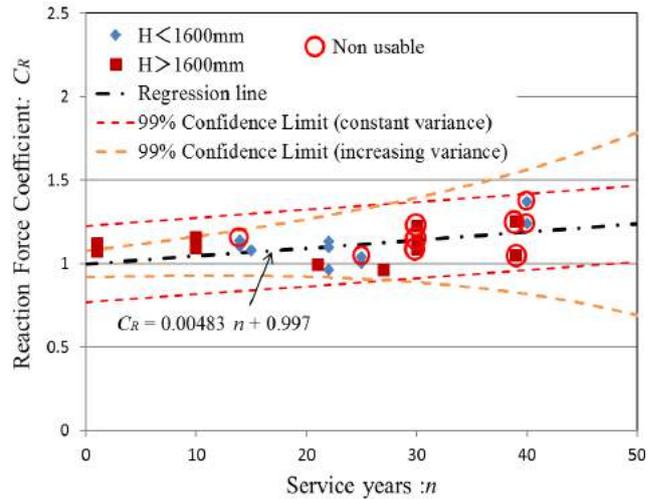
Fig.4 Reaction Force Coefficient by age: C_R
(Average of 2nd-3rd compression at 25%).

Fig.4 shows the reaction force coefficient by service years. The average of C_R plots indicates a slight increase with a tendency to spread to the right; this is relative to the number of years in service. The blue inclined square plots are mid-sized fenders smaller than 2m in height and the red square plots means large-sized fenders over 2m high. The plot with red circle means the fender was judged already unusable based on the degradation points in **Table 5**. FD No.11

(32 years), No.12 (32 years), No.15 (40 years), and No.16 (42 years) were also non-usable but not plotted in **Fig.3** as they could not be compressed three times. The average annual rate of 0.483% per year is based on the assumption that the initial value was 1.0, per the catalogue value. The maximum serviceable years obtained from the test results was approximately 30 years with two exceptions; the smaller-sized FD No.4 and FD No.8 because they showed uneven buckling and the signs of abnormal berthing (cut by the fixing bolt and exposed steel). Thus, the past abnormal berthing is supposed to be the reason for these early uneven bucklings rather than the dead weight of the frontal panel. The red dashed lines are upper and lower limit of 99% confidence interval. Conventionally, they are two straight lines running parallel to the average regression line. The plots indicate a spread towards the right and an increase in the deviation by the number years. The environment and conditions of use are different in every fender, thus it is understood that the range of variance spreads wider by service years. It is reasonable to express the confidence values by extending the range of variance in relation to service years. To simplify the phenomenon, the variance was assumed to increase by service years and the maximum likelihood method was used. The increasing variance is expressed by equation (2):

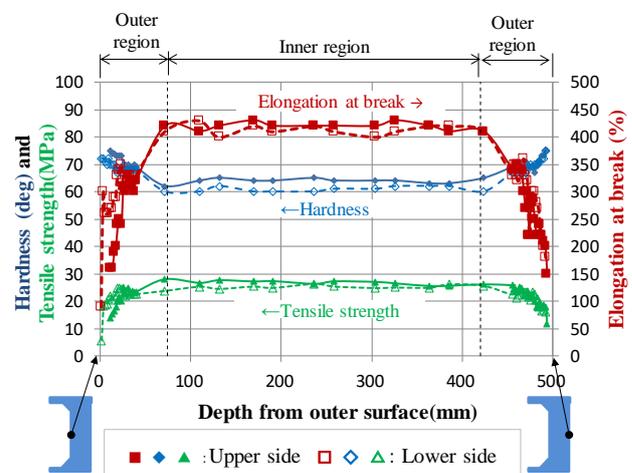
Fig.6 Distribution of material properties of FD No.11: 3000H(R0-10) after 32 years.

As the example of material test results, the distribution of material properties of FD No.11 are shown in **Fig.6**. The Y-axis represents hardness and tensile

In **Fig.6**, the critical depth is approximately 70mm from both the outer and inner surface of the body. As shown in **Table 1** and **Table 2**, FD No.11 was evaluated “Non-usable” because it could not be tested properly due to the cracks and uneven buckling. However, the physical properties of the inner region,

as shown in **Fig.6**, shows little deterioration. The service life of this fender may have been affected by the operational conditions rather than the material aging; therefore, a longer serviceable life may have been achieved if a different operational method was used. The initial value of rubber properties has a wide range of deviation due to the following facts:

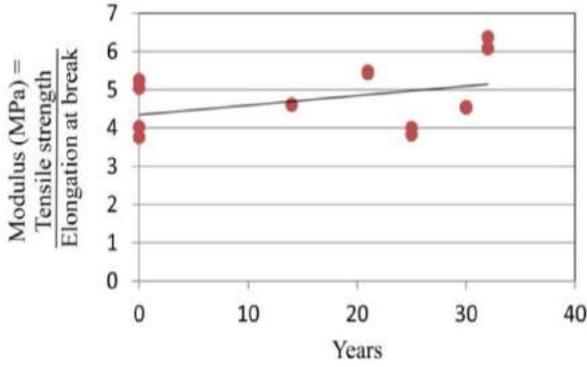
Fig.7 Aging of modulus of inner region: (Average tensile strength) / (Average elongation at break).

For reference, the example of modulus (Tensile strength/Elongation at breaking point) in relation to service years is shown in **Fig.7**. The modulus plots of each year are the sampling depths, which mean values of the inner region of the fender rubber bodies. The values at year 0 are the record of the quality test when manufactured. The rubber compounding has been modified a couple of times in the past thus it varies in the range of about 20%. Though the inner part of the rubber has no exposure/contact with oxygen, **Fig.7** indicates a moderate increase and **Fig.4** indicates an increase in reaction force. The variance of material also affects the variance of reaction force. The reason being that the free sulfur slowly re-entangles in links at normal temperature without the supply of oxygen. In order to discuss the aging impact of rubber, the material aging coefficient is used by dividing the property data (hardness, tensile strength, and elongation at breaking point) by the average value of the inner region. **Fig.8** is the material aging coefficient of FD No.11. Modulus in the outer region rises as it approaches the surfaces. **Fig.8** suggests that the coefficient of elongation at breaking point shows the distribution most clearly. Then, the comparison with other fenders are shown in **Fig.9**. Sueyasu⁹⁾ reported

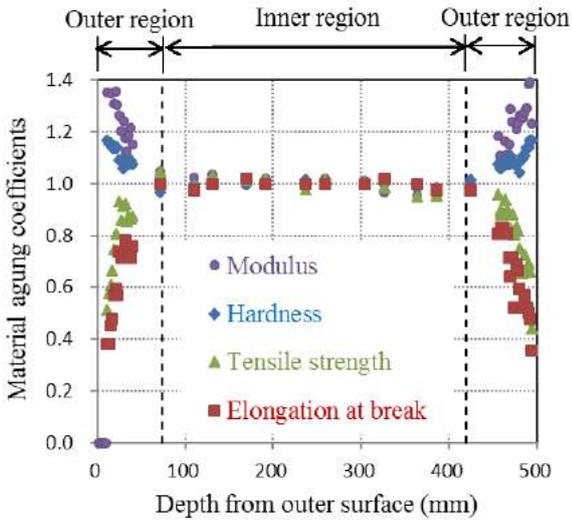
Fig.8 Distribution of material aging coefficient: FD No.11 3000H(R0-10), 32 years, Upper side.

property in the outer region deteriorates but does not extend to the inner region. The thickness of the outer region is called the critical depth: d_c which is proportional to the exponent of reciprocal of temperature as shown in equation (7):

the deterioration of 14 years in north Japan penetrated 20 to 30mm. This is smaller than 70 mm in **Fig.6** and **Fig.8**. The difference in average temperature between the north area and FD No.3 in the south island is about 15°C³⁾ which might be the reason for this difference in elongation coefficient. The calculated critical depths by Itoh et al⁸⁾ at each site location are shown in **Fig.9**. They look close to the measured distribution of FD No.8, 9, 10, and 11 (from 55 to 74mm) in **Fig.9** except for the 3000H-14 years in the north area where the critical depth is 102mm. Since the density of the data at the boundary between outer and inner region is insufficient, the exact critical depth cannot be clearly declared. However, in the coastal condition of Japan's climate, the average critical depth appears to be around 70 mm. The distribution of deterioration becomes flat at the area deeper than the critical depth. Thus, the material life is considered "still usable" after 30 years of service. On the other hand, smaller fenders (Ex. body thickness<140mm) will have more deterioration in the whole body. This is also suggested in **Table 2** which shows that smaller fenders have higher reaction forces.
