Approaches to Life Evaluation of Rubber Marine Fender

Abstract

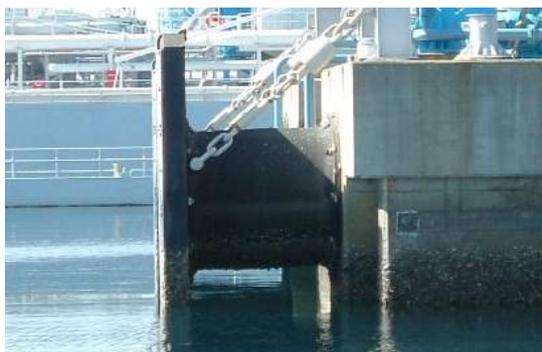
Fig.1 - Photo of Circular Shaped Buckling fender

fender (hereafter CSB) [3]. Figure 1 shows the photo of CSB fender with frontal panel and weight supporting chains. The authors focused on the CSB fender for the survey of old fenders and studied how to predict the performance change over time. The non-destructive inspection is the most practical method to evaluate the impact of aging but issues remain to be resolved.

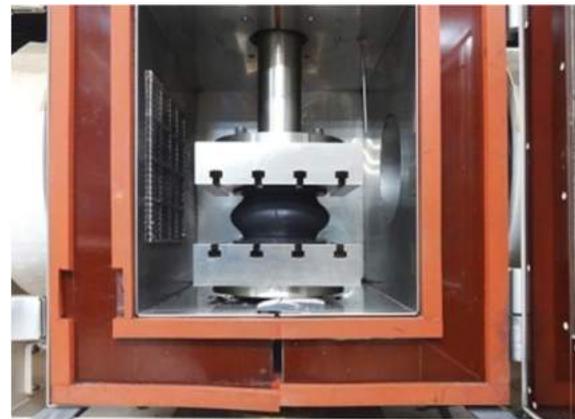
Miniature models were aged in a heat chamber at 80°C for 35, 70, 140 and 210 days which are equivalent to 17, 34, 68 and 102 years in normal temperature (23°C). Fig.8 shows the compression tester with heat chamber. The size of model was 100mm and compressed 3 times with the speed: 1mm/sec. The non-dimensional reaction forces of 2-3 cycle average are shown in Fig.9 and that of 1st compression is in Fig.10, respectively. The retracting curves with hysteresis loss of each performance are also shown. The model fender of 102 years aging was destroyed by the 1st compression, therefore 68 years is meant to be the maximum number of years during which this fender keeps flexibility to absorb berthing energy. Considering that the Arrhenius's method may have some error/s, the rate of reaction force (2.319 for the 1st and 1.325 for 2-3 average) is a more reliable index than number of years at which this fender has lost its function.

Fig.8 - Compression tester for miniature model
