INVESTIGATION ON SERVICE YEARS OF LARGE RUBBER MARINE FENDERS

Key Words : rubber fender, durability, service years, failure modes, compression test, field survey

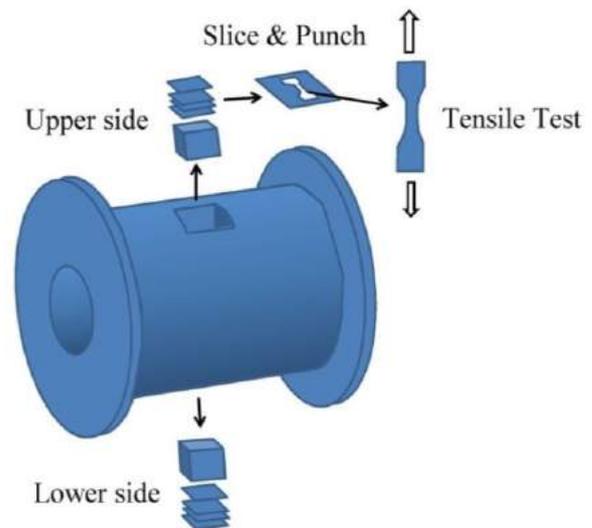
Fig. 5 Rubber sampling from returned fenders.

The material samples of 2mm thickness were made by slicing the rubber blocks in order to see how aging affects the thick rubber wall. This procedure is illustrated in **Fig.5**. The upper side had been facing the sky and the lower side had been facing down to the sea water.
